Fireside Corrosion in Oxy-fuel Combustion of Coal

Oxidation of Metals

DOI 10.1007/s11085-013-9399-6

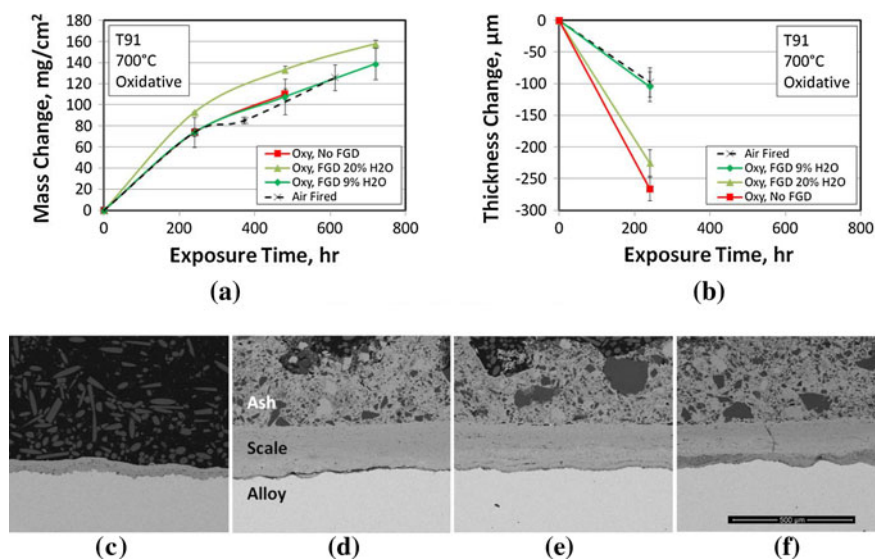
Fig. 5 T91 after exposure at 700 °C with 3 mm of ash (30 Fe₂O₃–30 Al₂O₃–30 SiO₂–5 Na₂SO₄–5 K₂SO₄). Back-scattered SEM images are after 240 h of exposure. **a** Mass change **b** Section change **c** Air-fired **d** FGD with 9 % H₂O **e** FGD with 20 % H₂O **f** without FGD

Results for T91 exposed at 700 °C are shown in Fig. 5. All of the as-cleaned samples showed significant amounts of ash still attached to the surface [6]. The ash attachment appears to result from iron oxide precipitation within the ash near the scale interface. This is consistent with a fluxing mechanism of hot corrosion in a non-protective case of a negative solubility gradient of oxide within the sulfate containing phase [8]. Hot corrosion fluxing is the dissolution of the protective scale. If there is a positive solubility gradient in the sulfate containing phase, then the sulfate will become saturated in the dissolved oxide and the corrosion rate will be low. If there is a negative solubility gradient, then the dissolved oxides will come out of solution (in a non-protective manner) and the corrosion reaction can continue unabated. The precipitated oxides within the ash can lead to ash attachment. Further analysis of the ash is needed for confirmation that this mechanism occurred. Because of the ash attachment, the mass gain data in Fig. 5a are not useful in describing the corrosion rate. Figure 5b shows metal thickness change results measured from cross-sections removed from one of the triplicate samples in each condition after 240 h. The metal loss results show more metal loss in the high water content oxy-fired no FGD and oxy-fired FGD with 20 % H₂O cases than in the other two environments. In all cases the metal loss was substantial.

EDX analysis showed a three-layered morphology in the oxy-fired scales. At the scale ash interface was a Fe–O layer, which was ~10 % of the scale thickness. The rest of the scale was divided into roughly equal thicknesses of a Fe–Cr–O layer in the middle and a Fe–Cr–O–S layer near the metal.

EDX analysis of the much thinner scale in the air-fired cross section in Fig. 5c showed an outer layer of Fe–O that was about the same thickness as in the oxy-fired cases. Below the Fe–O layer were some areas with a Fe–Cr–O–S and then a Fe–Cr–O layer (next to the alloy), and some areas with a sequence of Fe–Cr–O, Fe–Cr–O–S, and then Fe–Cr–O. The thinness of the scale and section losses similar to the Oxy FGD with 9 % H₂O case is evidence of spalling. A lack of, in some areas, a Fe–Cr–O layer between the Fe–O and Fe–Cr–O–S layers is consistent with the spalling occurring during the exposure—otherwise the Fe–O layer would not be present.
